**KEY INSPECTION SERVICES, LLC**  
#1 Home Education and Inspection Company

1234 Main St.  
Snohomish , WA 98296

11/05/2019 9:00AM

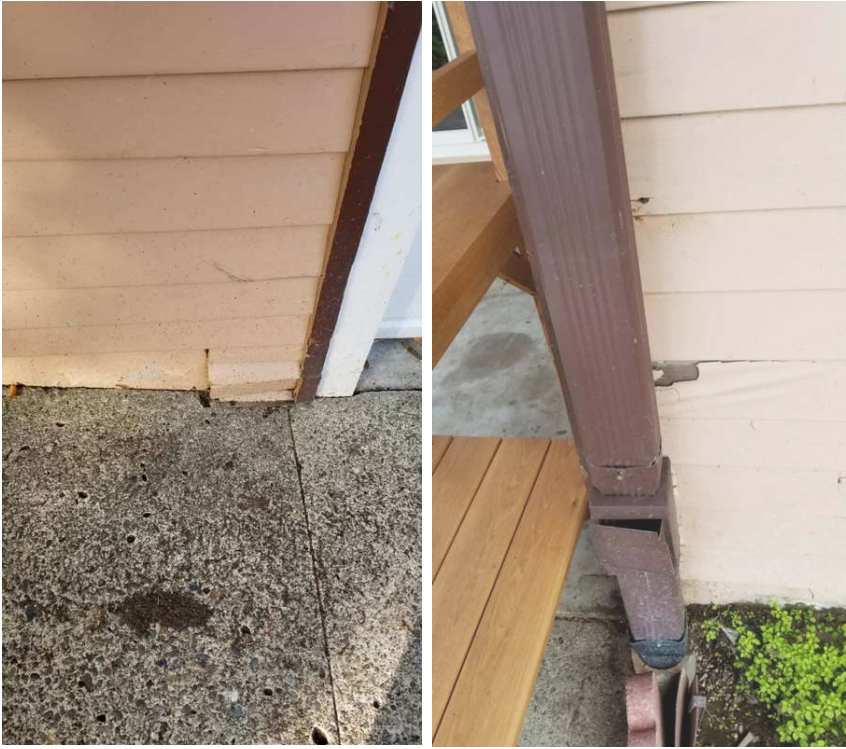
**DAMAGED SIDING**

Siding appears to be damaged numerous locations budget for repairs. I recommend evaluation and repair as needed.

Front

Rear

Contact a qualified siding specialist.

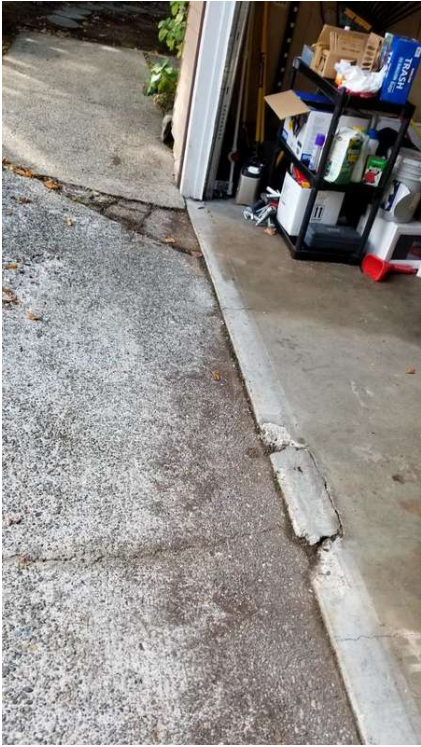
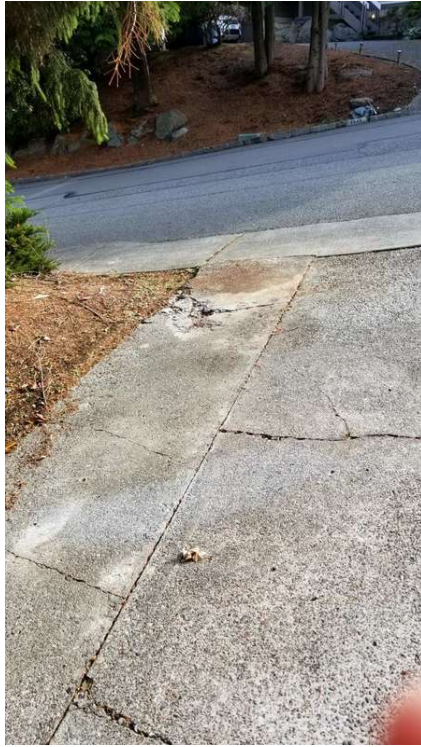
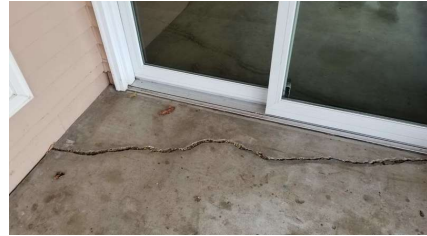
#### **DRIVEWAY TRIP HAZARD**

Trip hazards observed. Patch or repair recommended.

Recommended DIY Project

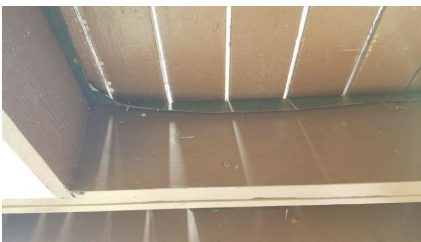
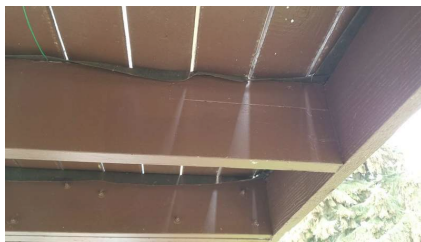
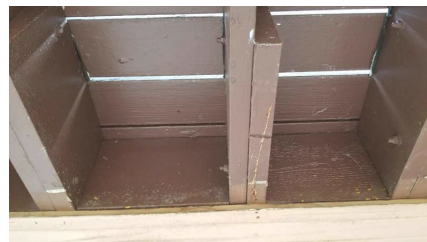
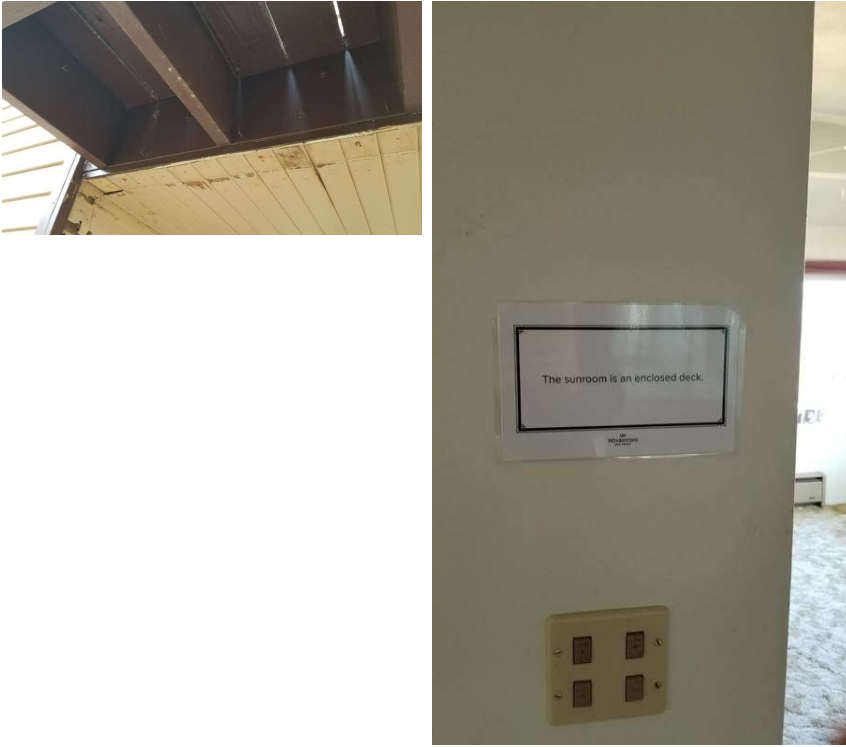
2.4.1 Decks, Balconies, Porches & Steps

Cantilever decking improper installation with sistered joists this can trap moisture and cause rot. Appears a structure was built on top of a deck. Recommend a 2nd story decking contractor evaluate for repair/replacement.

Contact a qualified deck contractor.

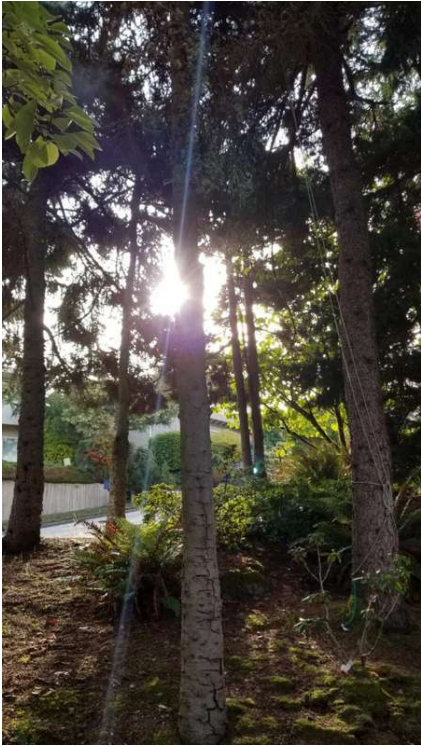
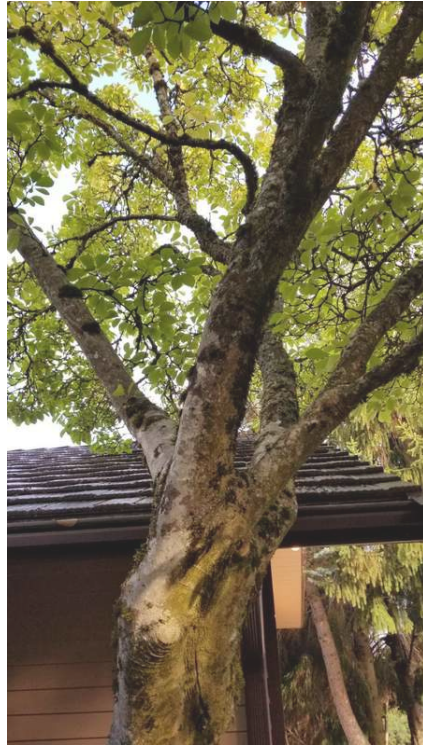
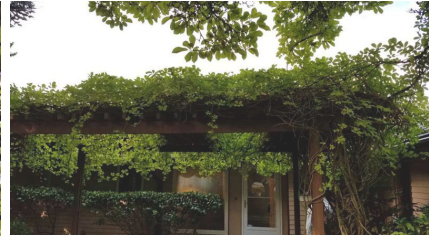
### 2.6.1 Vegetation, Grading, Drainage & Retaining Walls

There were a large amount of trees removed at the rear of the property. Unknown if this has compromised the soil stability and/or if these were permitted to be removed. For an accurate evaluation of the trees I recommend contacting a qualified arborist or tree expert. Inquire with seller regarding permits and the proper tree removal process.

Contact a qualified landscaping contractor

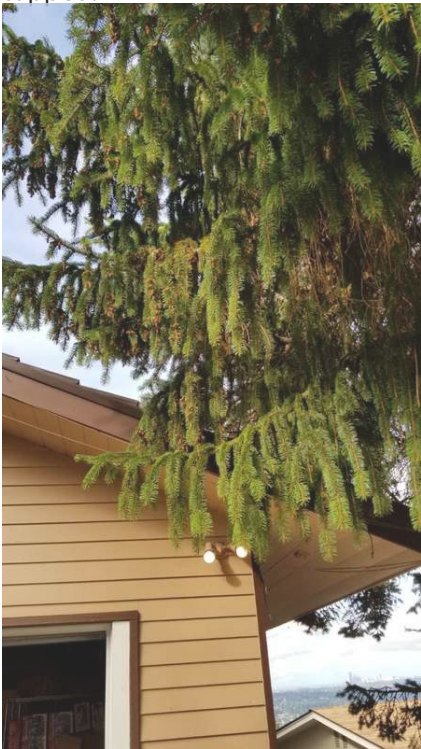
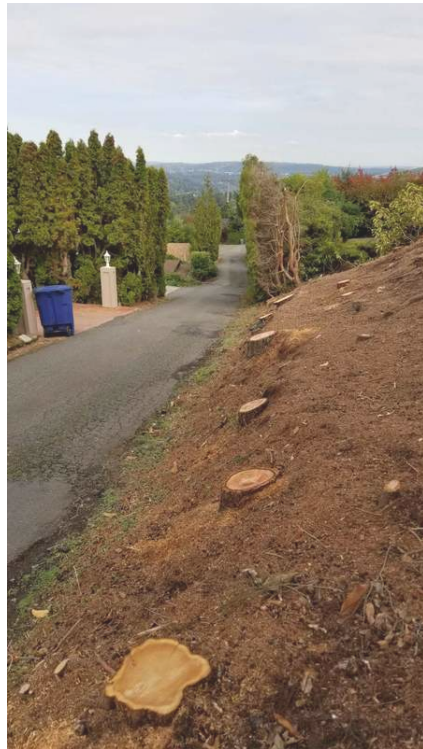
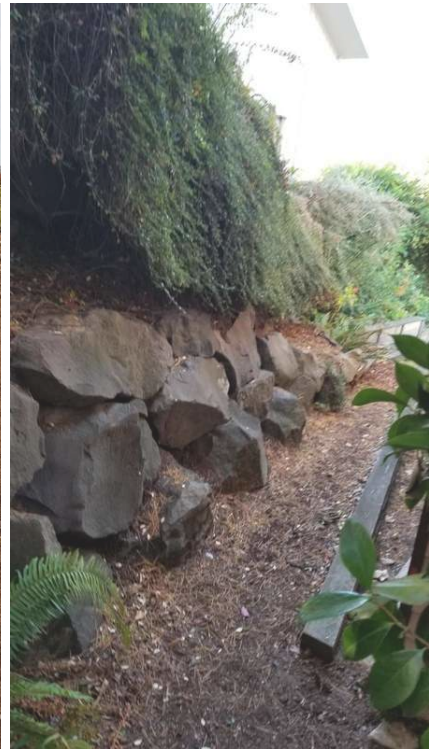
Appears to be a dead tree front of house. A lot of trees appear topped.

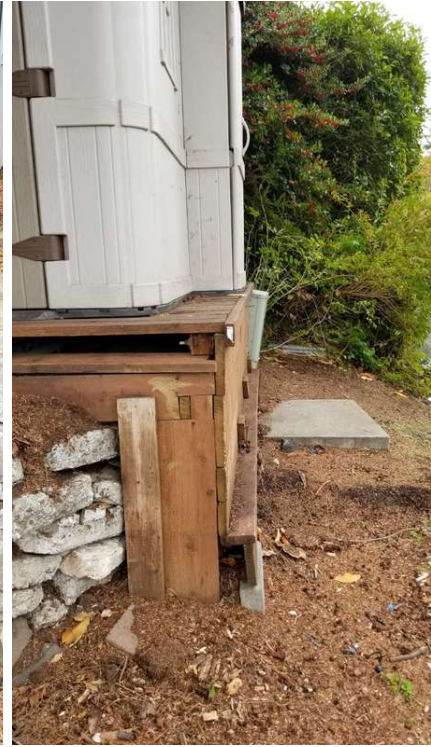
2.6.2 Vegetation, Grading, Drainage & Retaining Walls

**RETAINING WALL CRACKS**

Retaining wall is showing signs of failing. Recommend qualified contractor evaluate and repair.

Contact a qualified landscaping contractor

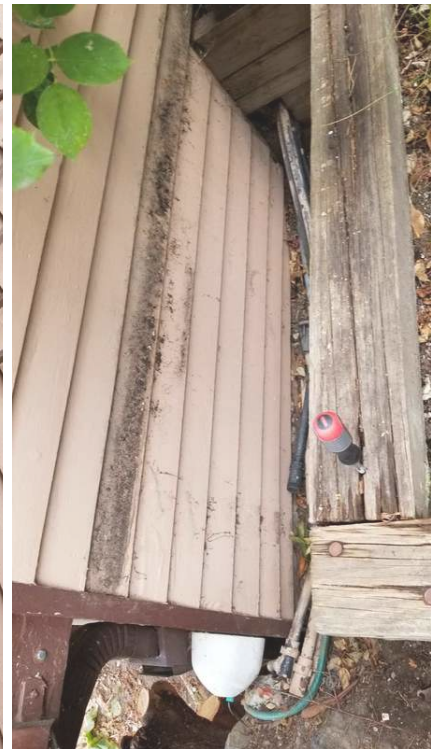
2.6.3 Vegetation, Grading, Drainage & Retaining Walls

**SOIL TO WOOD CONTACT**

There appears to be soil to wood contact. This is a conducive condition to potential rot. I recommend a qualified landscape professional to repair or replace as necessary.

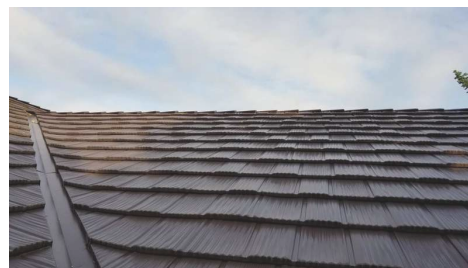
Roof covering appears to be metal. Often times this type of roof covering comes with a transferable warranty. Inquire with seller regarding the existence of a transferable warranty. Minimal inspection from ladder at eave due to metal roofs denting and easy to damage.

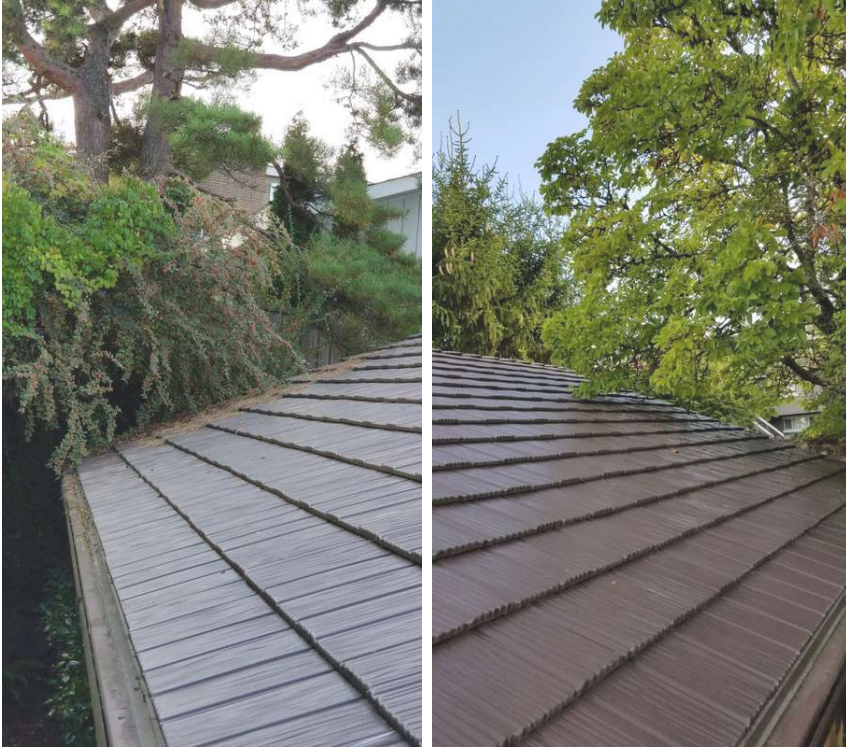
### 3.1.2 Coverings

Trees hanging over roof need to be cut back to prevent damage to the structure.

Contact a qualified professional.

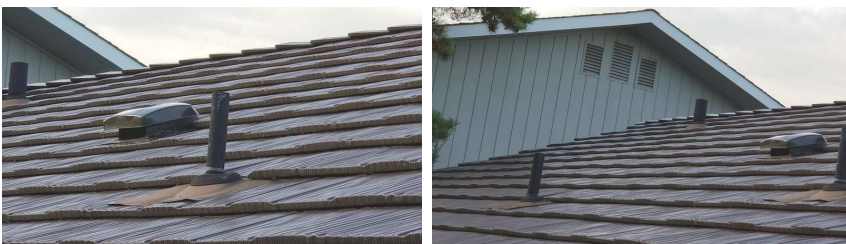
3.2.1 Roof Drainage Systems

**IMPROPER FLASHING SYSTEM**

Poor flashing system installed on rubber boots for plumbing. Signs of inverted flashing system budget for repairs.

Contact a qualified roofing professional.

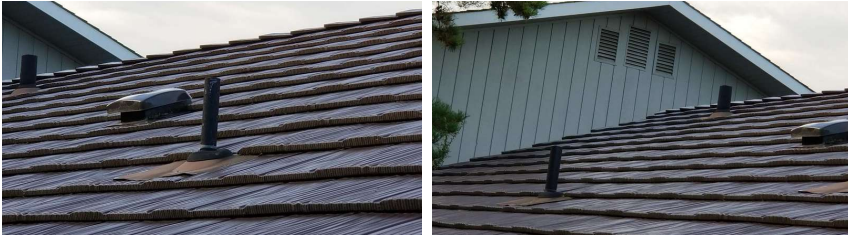
3.3.1 Flashings

**IMPROPER FLASHING SYSTEM**

Contact a qualified roofing professional.

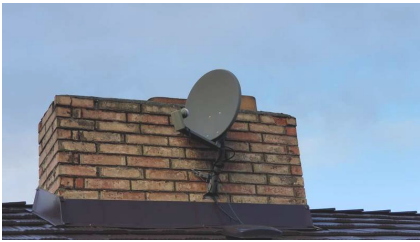
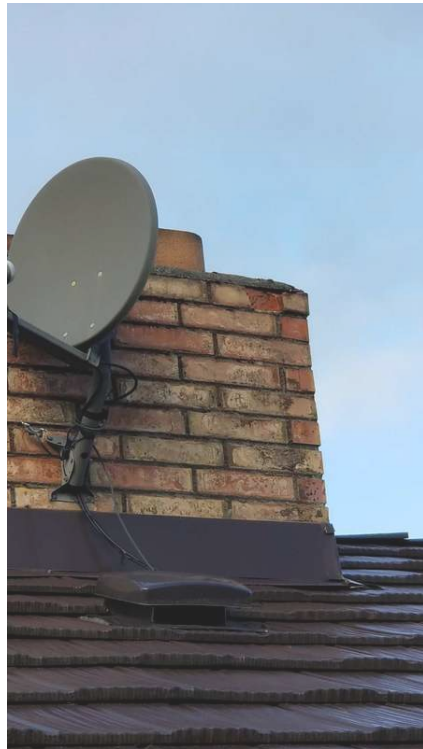
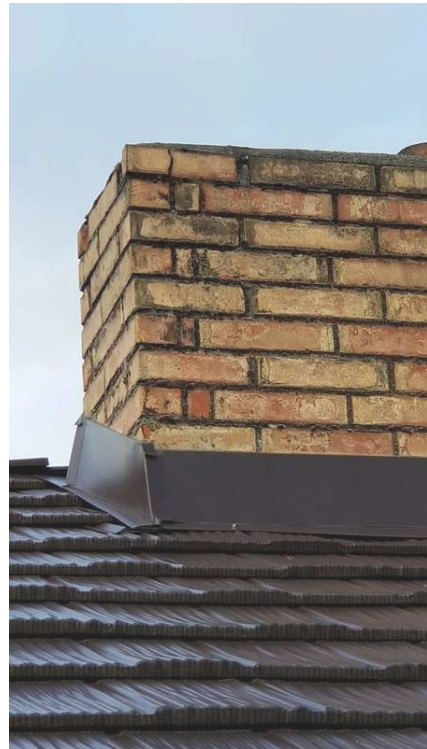
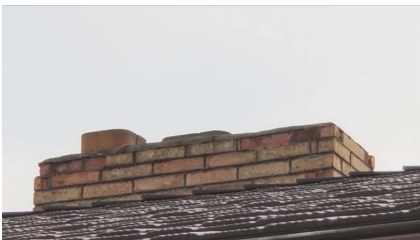
3.4.1 Skylights, Chimneys & Other Roof Penetrations

**MISSING SPARK ARRESTOR**

Missing spark arrestor on top of chimney. A missing spark arrestor can allow pest entry into the chimney, allow water to enter the chimney and freeze, potentially damaging the firebox/damper/chimney/etc., as well as allowing fire embers to exit the home, potentially leading to fire hazards. Recommend a qualified chimney sweep evaluate for cleaning and repairs.

Cracked bricks recommend further review.

Cracked bricks

Contact a qualified chimney contractor.

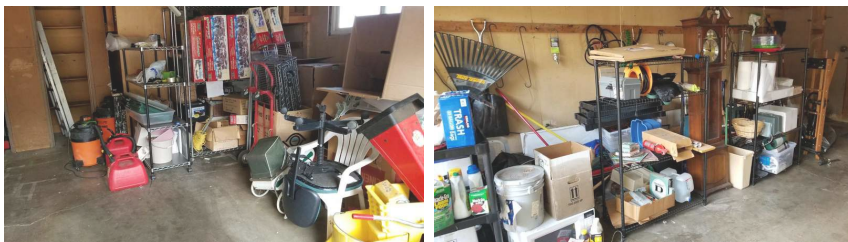
### HOME OWNER ITEMS LIMITING VIEW

Garage minimally inspected due to home owner items present at time of inspection. Recommend reviewing this area during walk through.

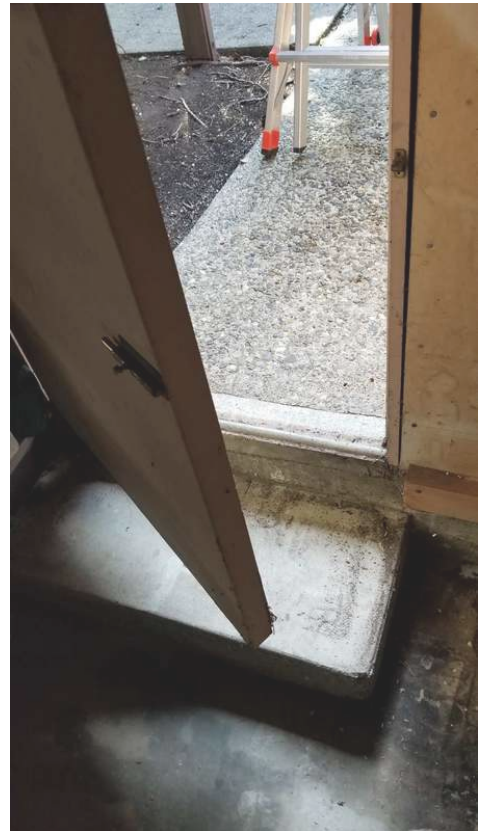
4.4.2 Occupant Door (From garage to inside of home)

The garage door opens over a step down. This is a potential safety hazard due to the possibility of a person entering without knowing a step is there. I recommend repair for increased safety.

Contact a qualified door repair/installation contractor.

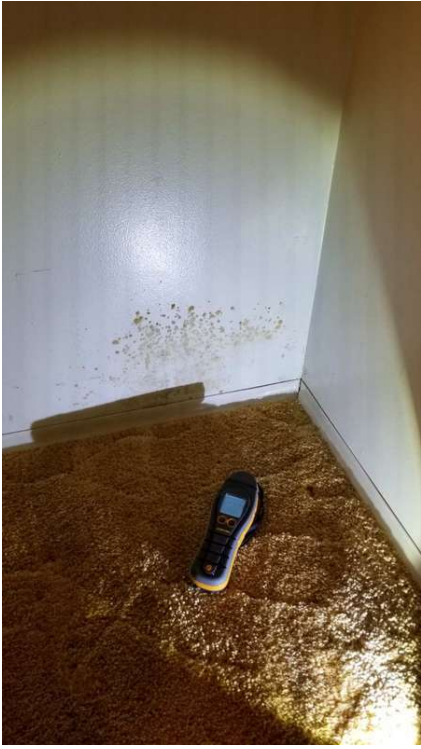
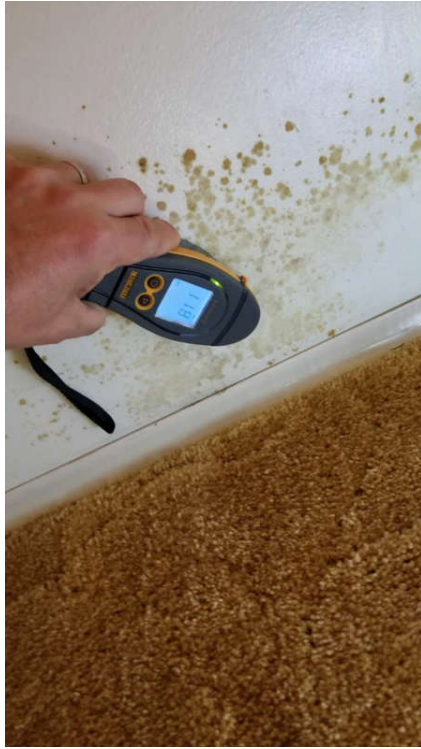
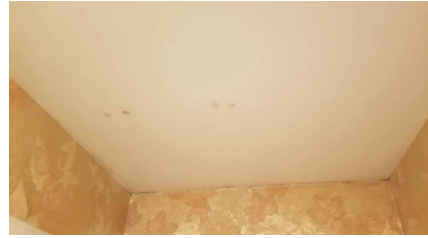
Residue appears fungal in nature on ceiling. I did not inspect, test or determine if this growth is or is not a health hazard. This type of testing is beyond the scope of a standard home inspection. The underlying cause is moisture or dampness. No obvious elevated moisture at time of inspection. Fungus noted numerous locations. Dry at time of inspection.

Master closet

Contact a qualified environmental contractor

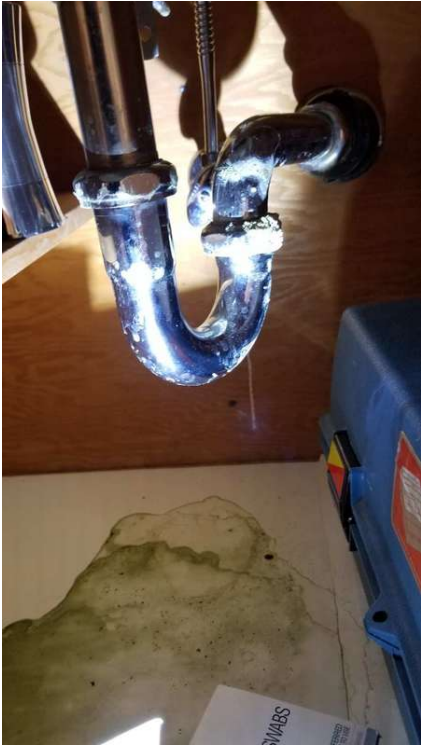
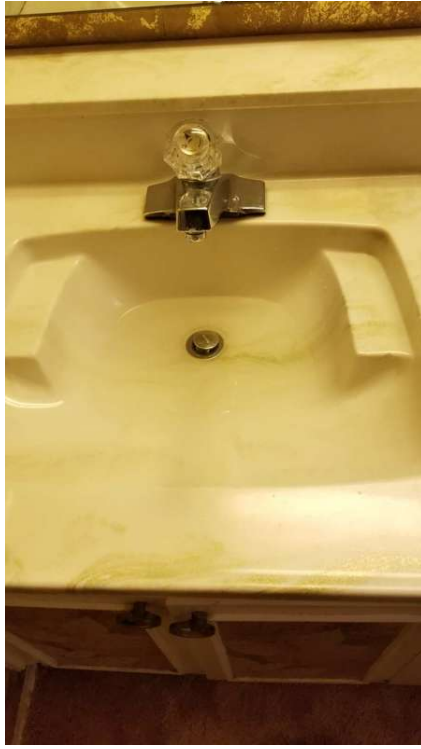
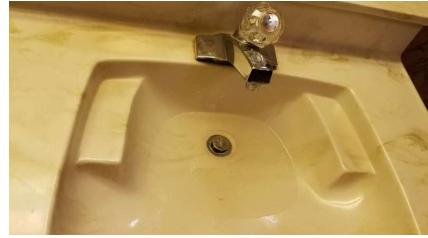
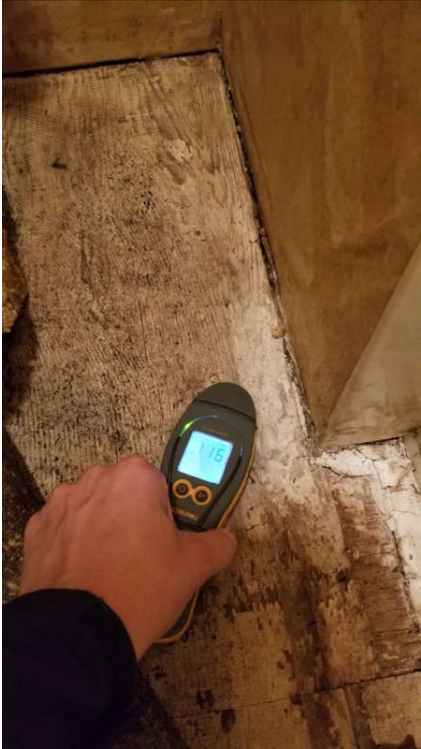
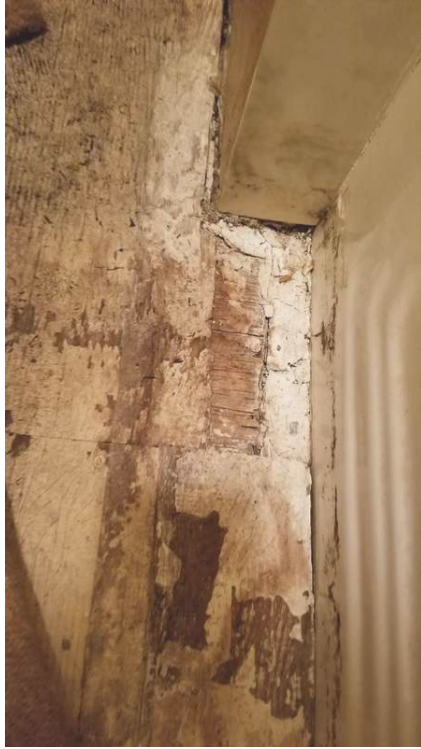
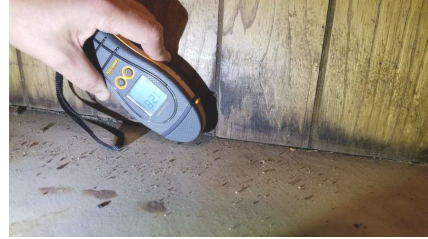
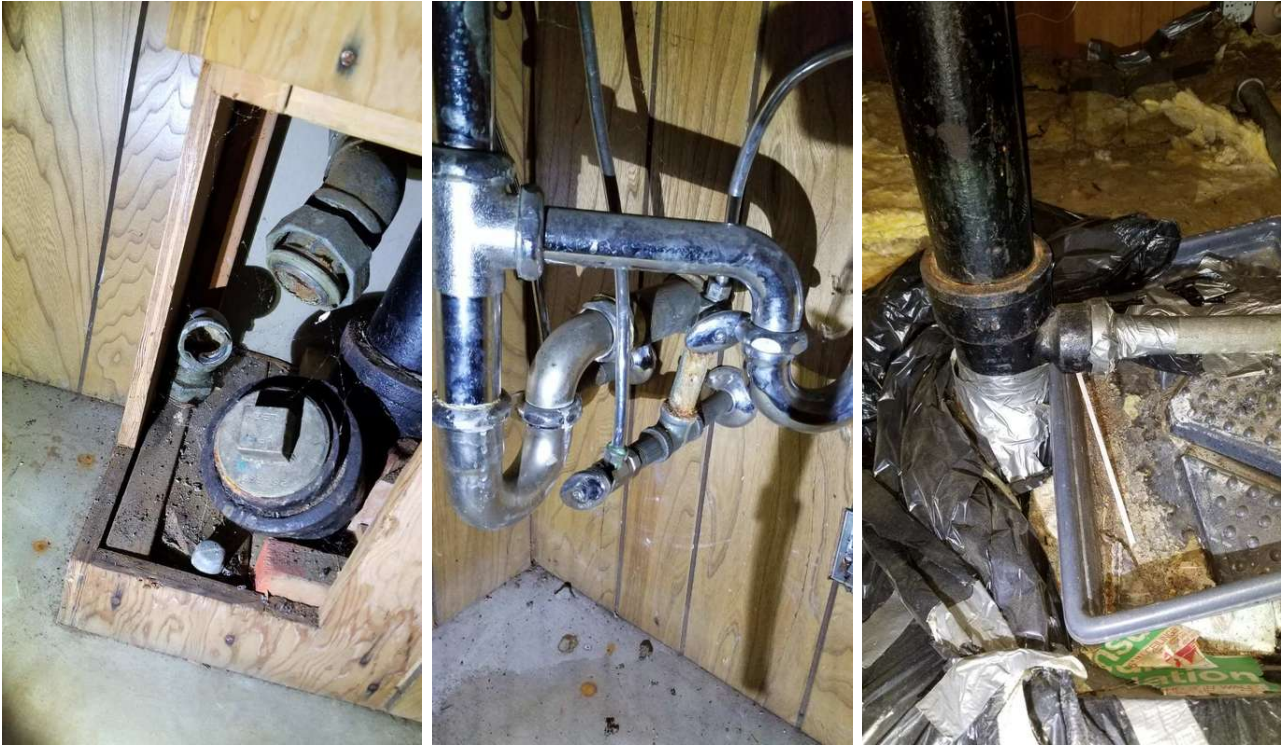
**DRAIN LEAKS**

Leak noticed in the drain lines in the bathroom sinks. We recommend a qualified plumbing contractor evaluate and repair/replace as needed.

Master bathroom

Rotting floor master

Contact a qualified plumbing contractor.

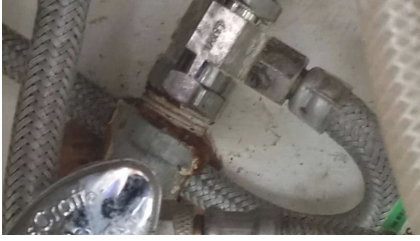
### 6.2.1 Water Supply, Distribution Systems & Fixtures

#### **DISTRIBUTION PIPE LEAKING**

Distribution pipe appeared to be leaking. Recommend a qualified plumber evaluate and repair. Aged galvanized plumbing with signs of corrosion and leakage throughout the home. Recommend budgeting for complete replacement.

Kitchen

Contact a qualified plumbing contractor.

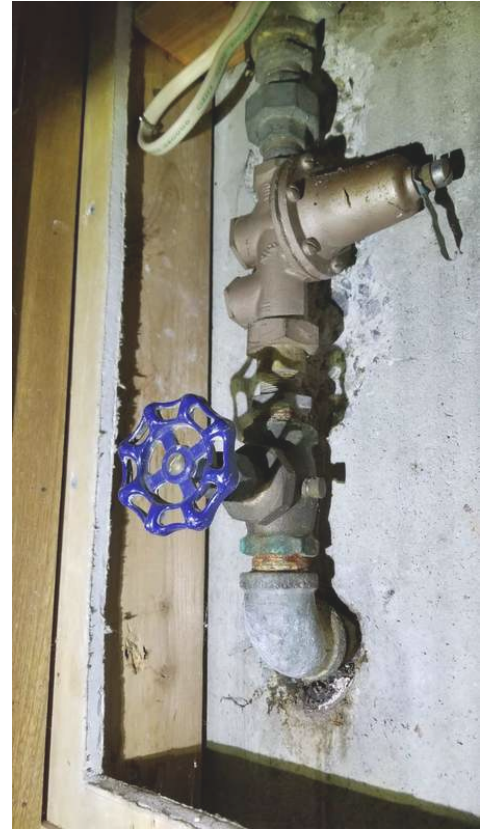
**MAIN WATER SUPPLY PIPE CORRODED**

Main water supply pipe was heavily corroded. This can lead to shortened lifespan of the pipe. Recommend a qualified plumber repair.

Contact a qualified plumbing contractor.

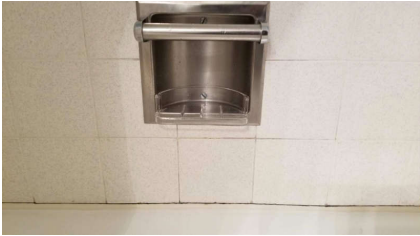
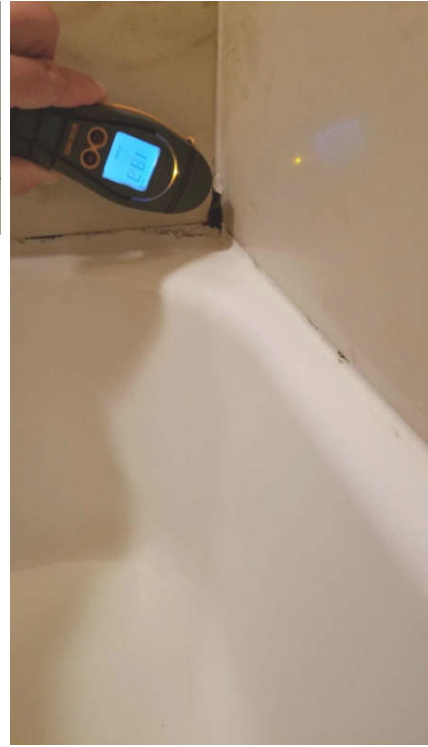
## 6.2.5 Water Supply, Distribution Systems &amp; Fixtures

Shower showing signs of moisture intrusion. High likelihood of rot damage behind the wall due to the construction methods of the time period (i.e. sheetrock only). We recommend budget for rebuilding the shower surrounds.

Guest bath tile movement

Moisture in master shower

Contact a qualified tile contractor

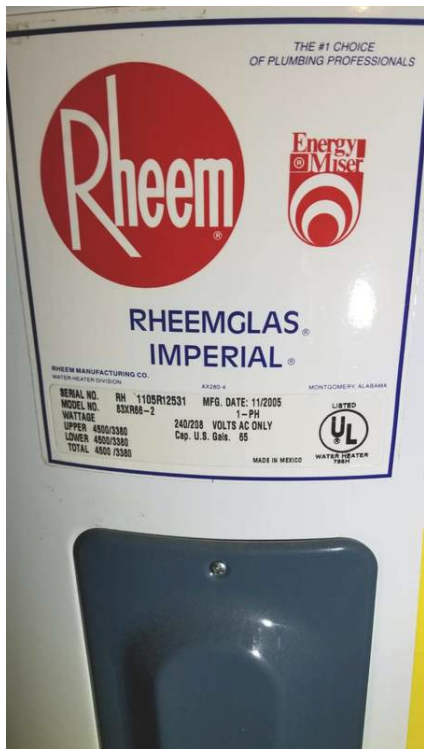
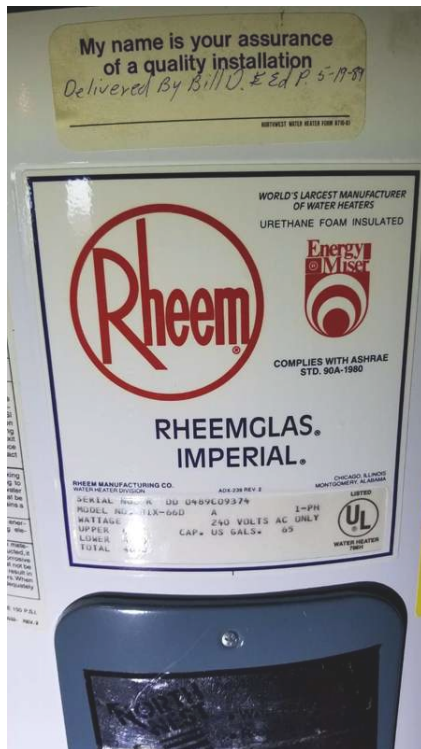
6.3.1 Hot Water Systems, Controls, Flues & Vents

The water heater is nearing the end of its design life. Standard life is 8-12 years this water heater appears to be 12 & 19 years old. No obvious leaks or rust at time of inspection. I recommend budgeting for repair/replacement.

Contact a qualified plumbing contractor.

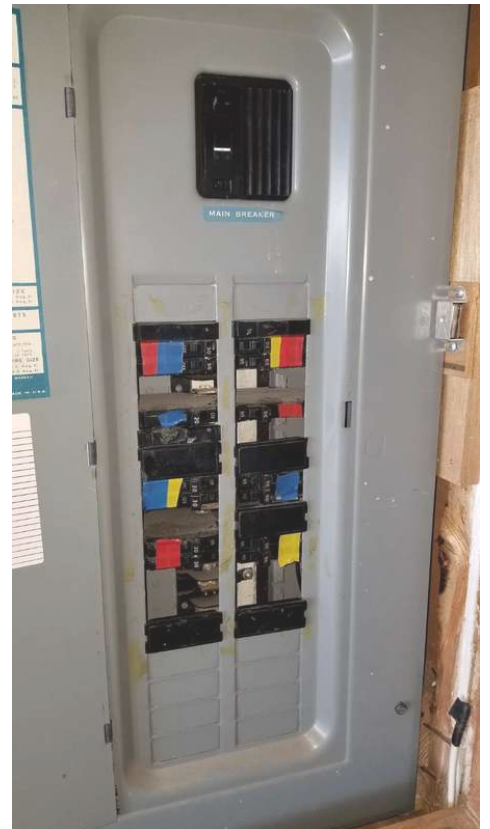
7.2.1 Main & Subpanels, Service & Grounding,  
Main Overcurrent Device

### **TWIST OUTS MISSING**

Twist-outs/knock-outs missing at electrical panel. This has a potential for improper human contact. Generally, a simple fix by a qualified professional but does pose a safety hazard. Immediate correction is recommended.

Contact a qualified electrical contractor.

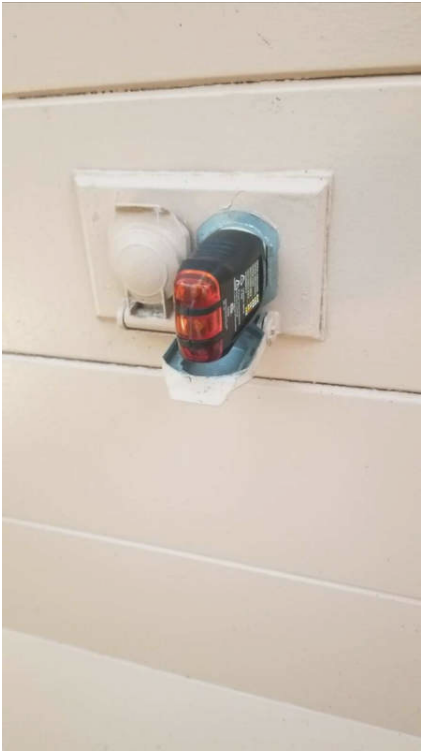
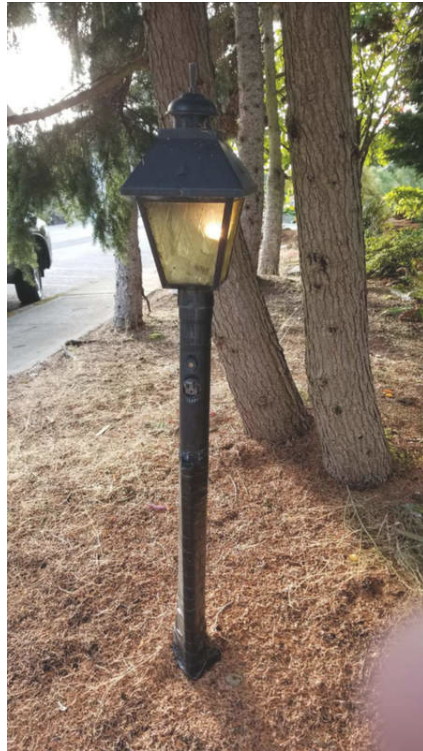
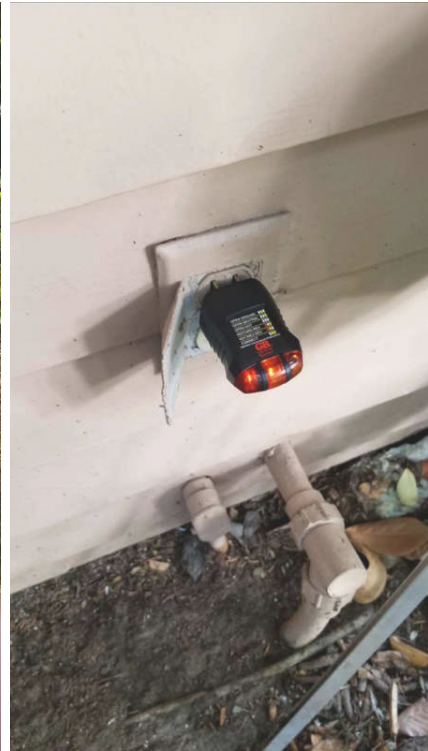
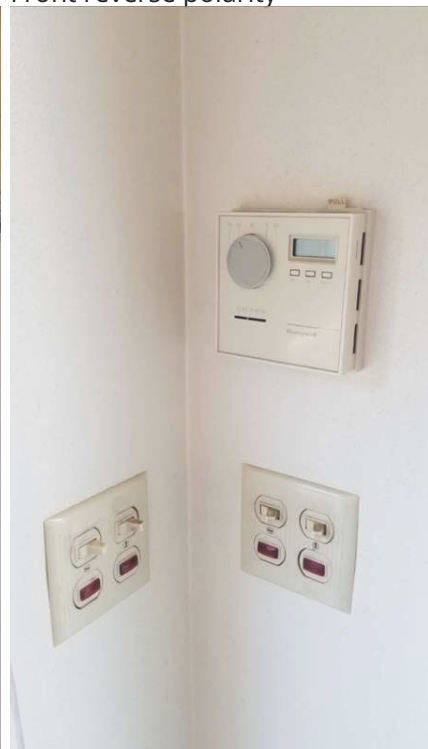
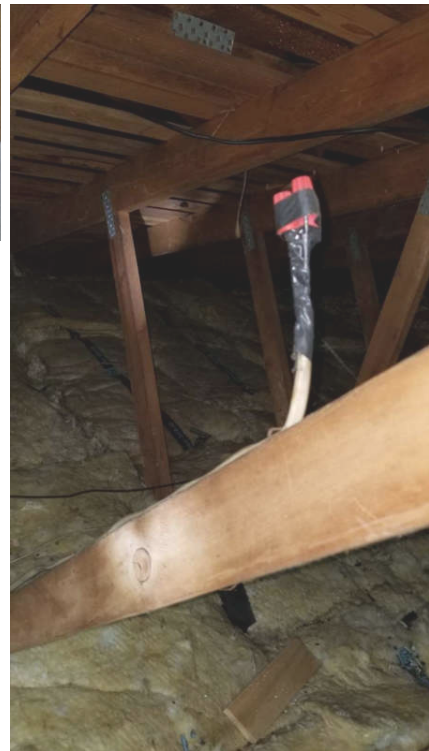
7.3.1 Lighting Fixtures, GFCI, AFCI, Switches & Receptacles, Branch Wiring Circuits

Non-standard outdated electrical system throughout the home. Some light switched did not turn off lights in the room and other turned off other rooms. We recommend budgeting for a significant rewiring due to the outdated wiring system, lack of proper installation and maintenance.

Numerous two prong outlets throughout home. This is typical for the age of home. I recommend upgrading to grounded outlets and/or installing properly wired GFCI outlets to increase safety to electrically sensitive equipment (i.e. radio, TV, computer).

Entryway non-operable

Broken driveway safety hazard

Front reverse polarity

Unknown in solarium

Attic

Contact a qualified electrical contractor.

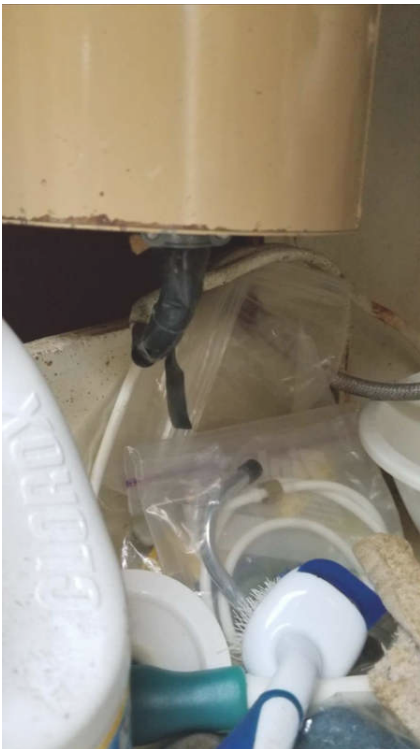
All exposed wiring for the lights in the cabinets should be properly protected with conduit. I recommend a qualified electrical contractor repair/replace as needed for increased safety.

Kitchen

Contact a qualified electrical contractor.

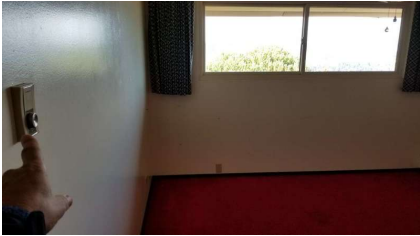
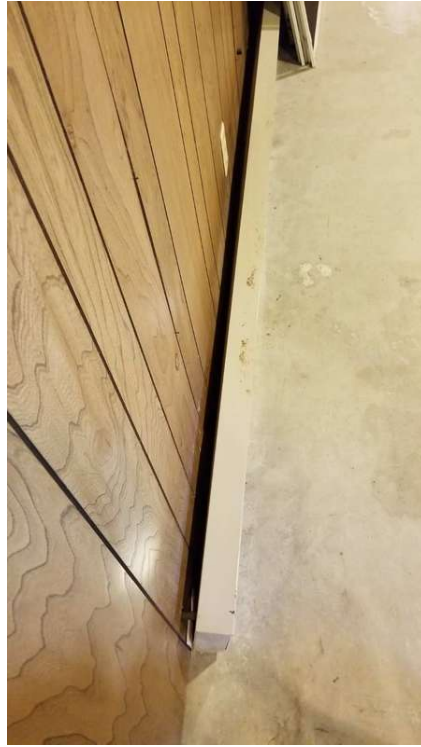
The room appears to be missing any heat source at the time of inspection. I recommend a qualified electrician to repair replace as necessary. Unable to verify operation of electric heat, in ceiling, floors or walls. The aged baseboard heating system was detached from the wall numerous location and not tested due to safety hazard potential. Recommend a qualified HVAC contractor reevaluate the entire heating system for repair/replacement. Hydronic heating may be a great upgrade.

Contact a qualified electrical contractor.

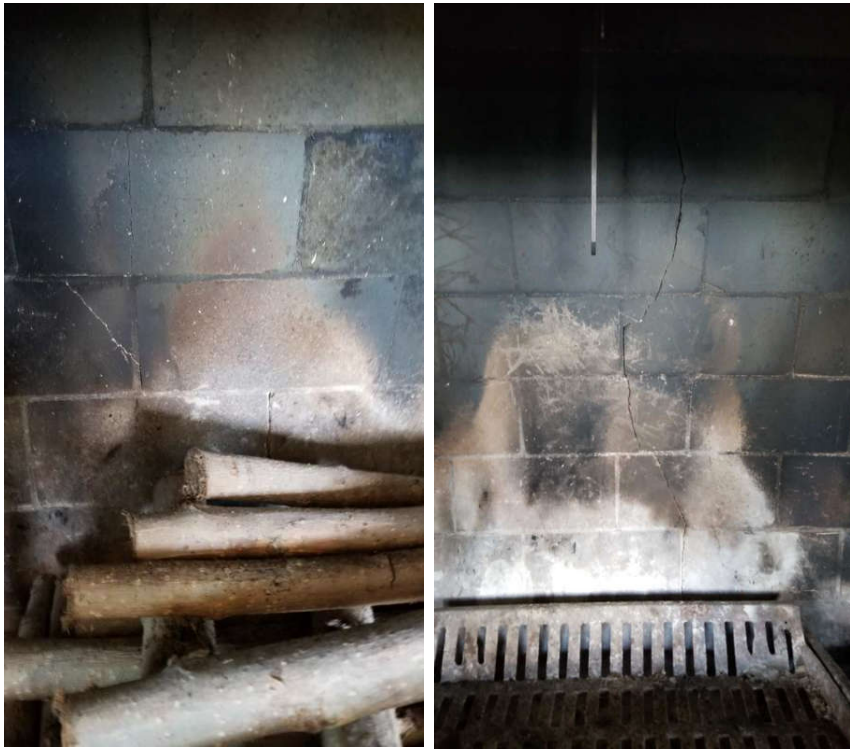
8.4.1 Gas/LP Firelogs & Fireplaces

**CRACKED WARPED BRICKS IN FIREBOX**

Bricks in Fire box appear to be cracked/warped. I recommend evaluation and repair as needed by a qualified chimney sweep prior to use.

Contact a qualified chimney contractor.

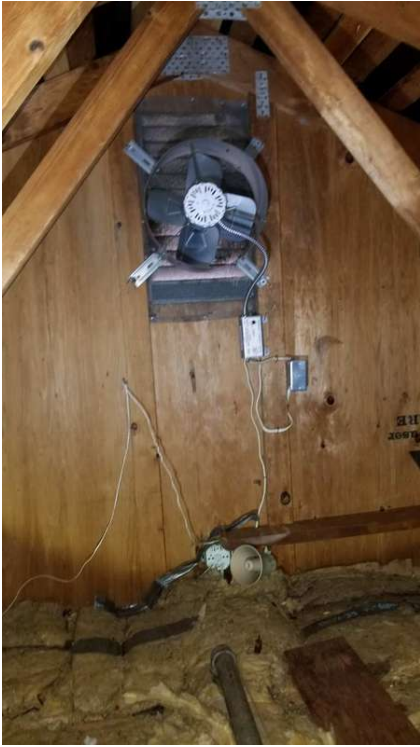
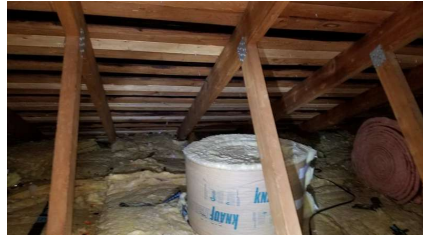
### 9.3.1 Ventilation

#### **NON-OPERABLE FAN**

The fan appeared to be non-operable at the time of Inspection. I recommend a qualified HVAC technician to repair/replace.

Soffit vents not installed. Non-standard electrical installation in attic. Refer to electrician for repair/replacement.

Contact a qualified HVAC professional.

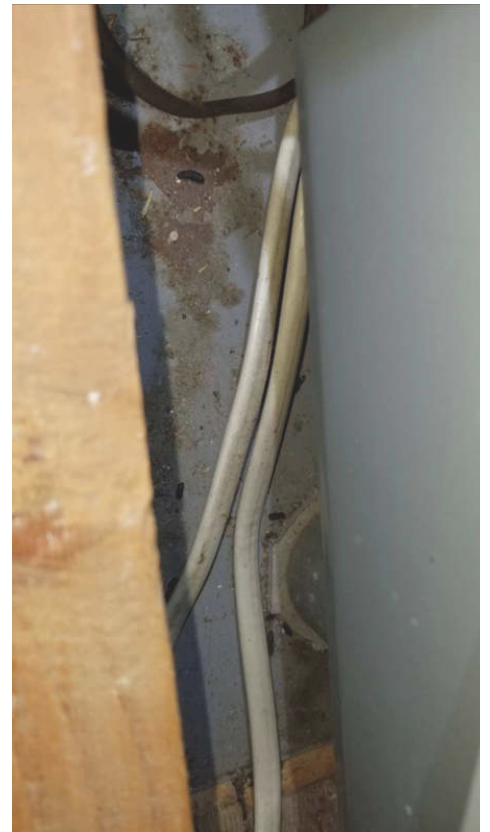
10.1.2 Foundation, Basements and crawlspace.

Near electrical panels

Contact a qualified pest control specialist.
